SITE ID 355: GARDNER DENVER MACHINERY, INC. SITE SUMMARY REPORT

Onondaga Lake Project Task 5: 104(e) Review

Site No. 734030-002 Work Assignment Number D003060-27

TAMS Consultants, Inc.655 Third Ave.
New York, New York 10017

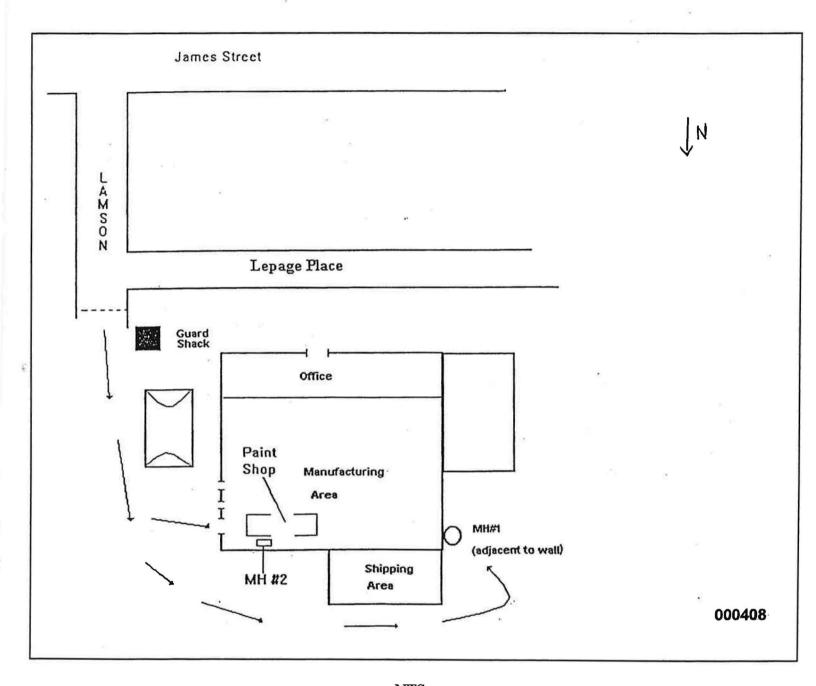
Figure 3 Industrial Site Plan

construction of this [on-site sewage disposal] plant or operations conducted at the plant" (Mailing No. 1, p. 000004). An industrial site plan provided by Gardner Denver is provided herein as Figure 3 (Mailing No.1, p.000408) which indicates the location of the paint shop, manufacturing area, shipping area, and two municipal sanitary sewer manholes.

It is likely that some stormwater runoff on site drained into the two manholes located outside the manufacturing operations building as shown on an industrial site plan provided in Mailing No. 1 (p. 000408). This industrial site plan is contained herein as Figure 3. No specific information regarding stormwater quality or stormwater runoff management at the Gardner Denver facility was provided in the documents available for review.
